Manhole Inspection Summary

Manhole # S5100_003MH

Insp Date: **3/17/08 9:29 AM**

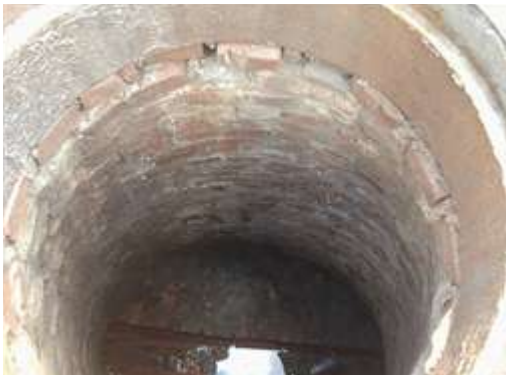
Defect 1

Condition: ☐ Sound ☐ Cracked ☐ Root Intrusion ☒ **Loose Brick** ☐ Deteriorated

Infiltration: ☐ None ☐ Joint ☐ Cracks ☒ **Mortar** ☐ Roots ☒ **Wall**

Loose Bricks

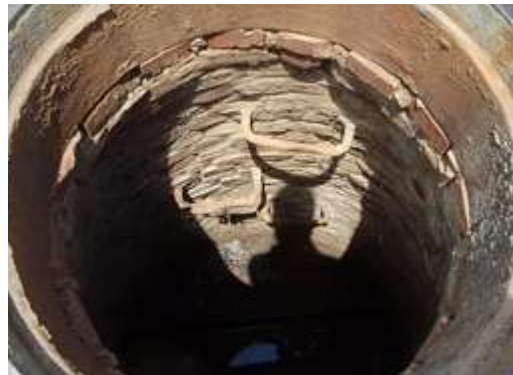
Defect 2

Frame Offset: **2** (in.) Condition: ☐ Sound ☐ Cracked ☒ **Leaks**

Frame Leaks

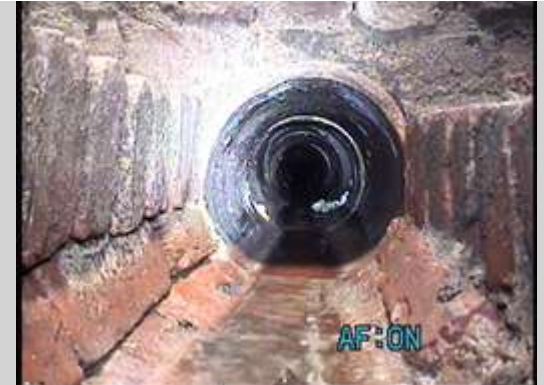
12 O'Clock Outflow

8 in. Circular Gravity Sewer
Pipe Out @ 12 O'Clock

Pipe Height: **8.4** (in.) Rod and Bar (Angled)
Pipe Material: **Clay** ☐ Pipe Lined
Invert Depth: **7.75** (ft.) Flow Characteristics: **Fast**
Deposits: ☒ None ☐ Mud ☐ Sludge ☐ Debris ☐ Grease
Silt Depth: (in.) Deposits Extent:
Infiltration: **None** Pipe Seal Cond: **Sound**

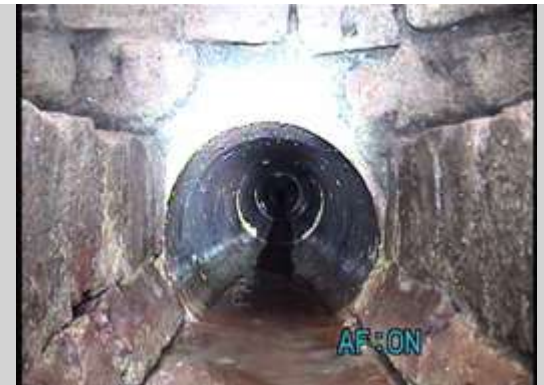
6 O'Clock Inflow

8 in. Circular Gravity Sewer
Pipe In @ 6 O'Clock

Pipe Height: **8.4** (in.) Rod and Bar (Angled)
Pipe Material: **Clay** ☐ Pipe Lined
Invert Depth: **7.70** (ft.) Flow Characteristics: **Fast**
Deposits: ☒ None ☐ Mud ☐ Sludge ☐ Debris ☐ Grease
Silt Depth: (in.) Deposits Extent:
Infiltration: **None** Pipe Seal Cond: **Unknown**
